TECHNICAL REPORT GL-86-5

EVALUATION OF WATERWAYS EXPERIMENT STATION DEVELOPED ALUMINUM ACCESS/EGRESS MODULES

Geotechnical Laboratory

May 1986
Final Report

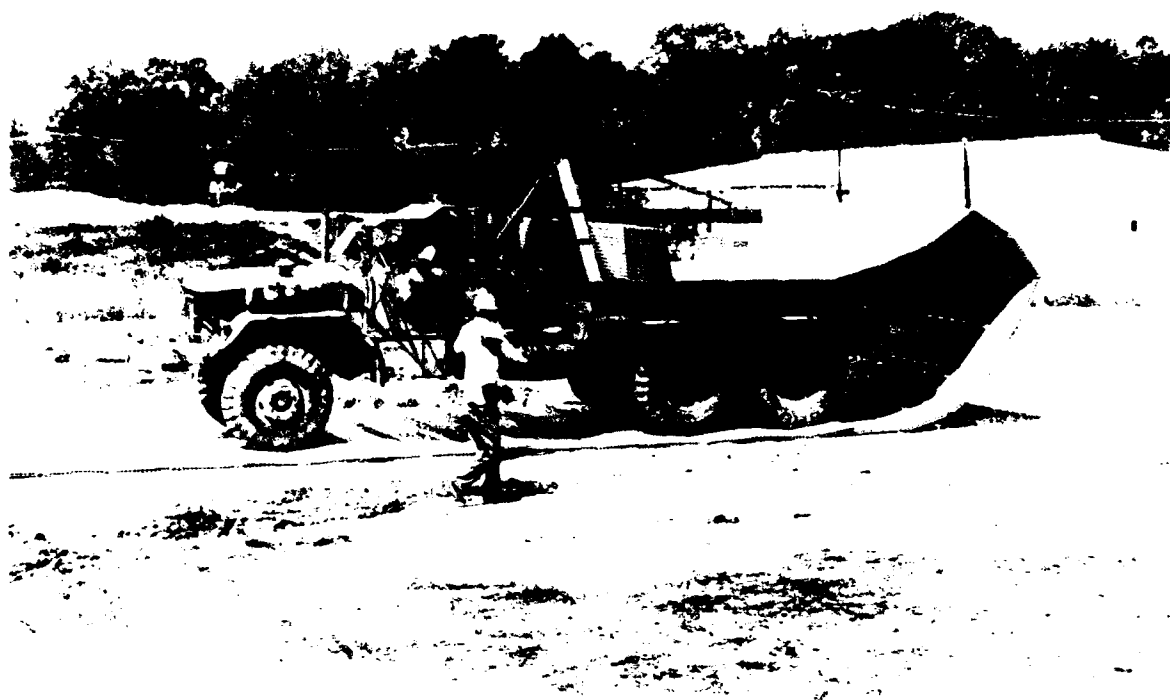
Photo 25. Modules being deployed from dispenser

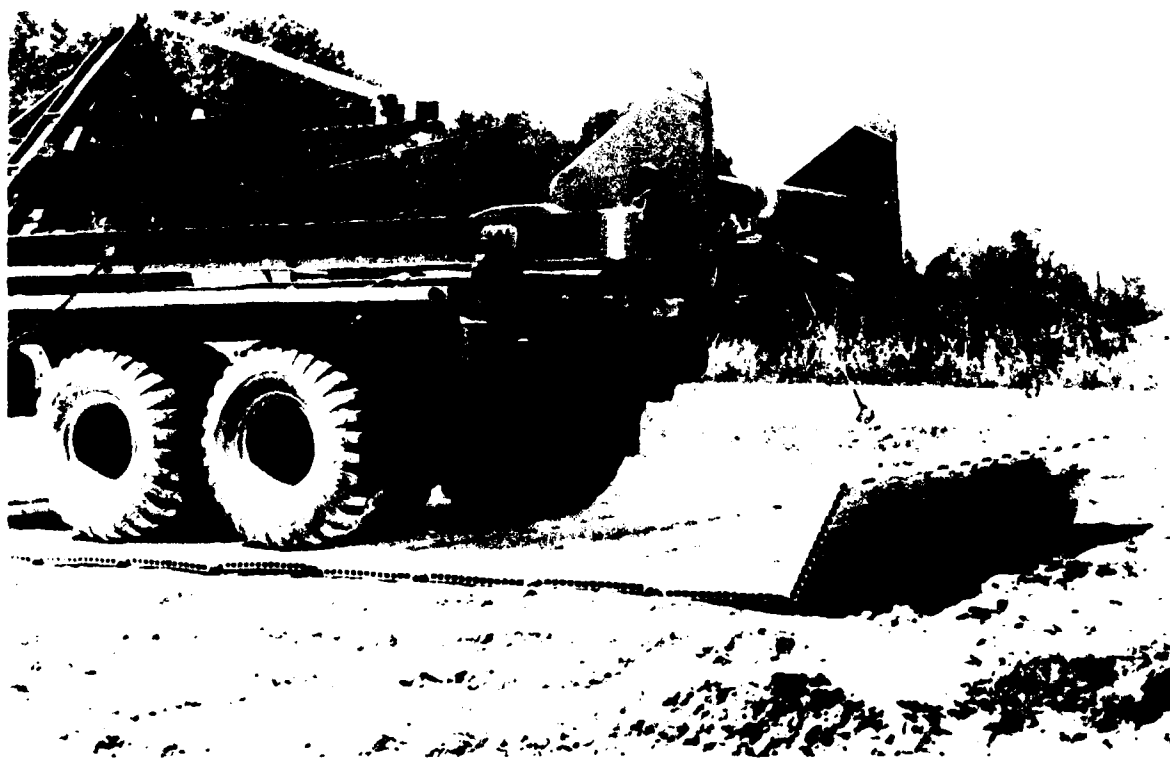
Photo 26. Beginning the retrieval process

25. To retrieve the modules, the RBT backed over the surfacing to the last panel. Winch-controlled cables connected at the inside snatch blocks pass through grooves on the triangular-shaped sprockets and down to the first panel where they are hooked to cable loops as shown in Photo 26. The winch

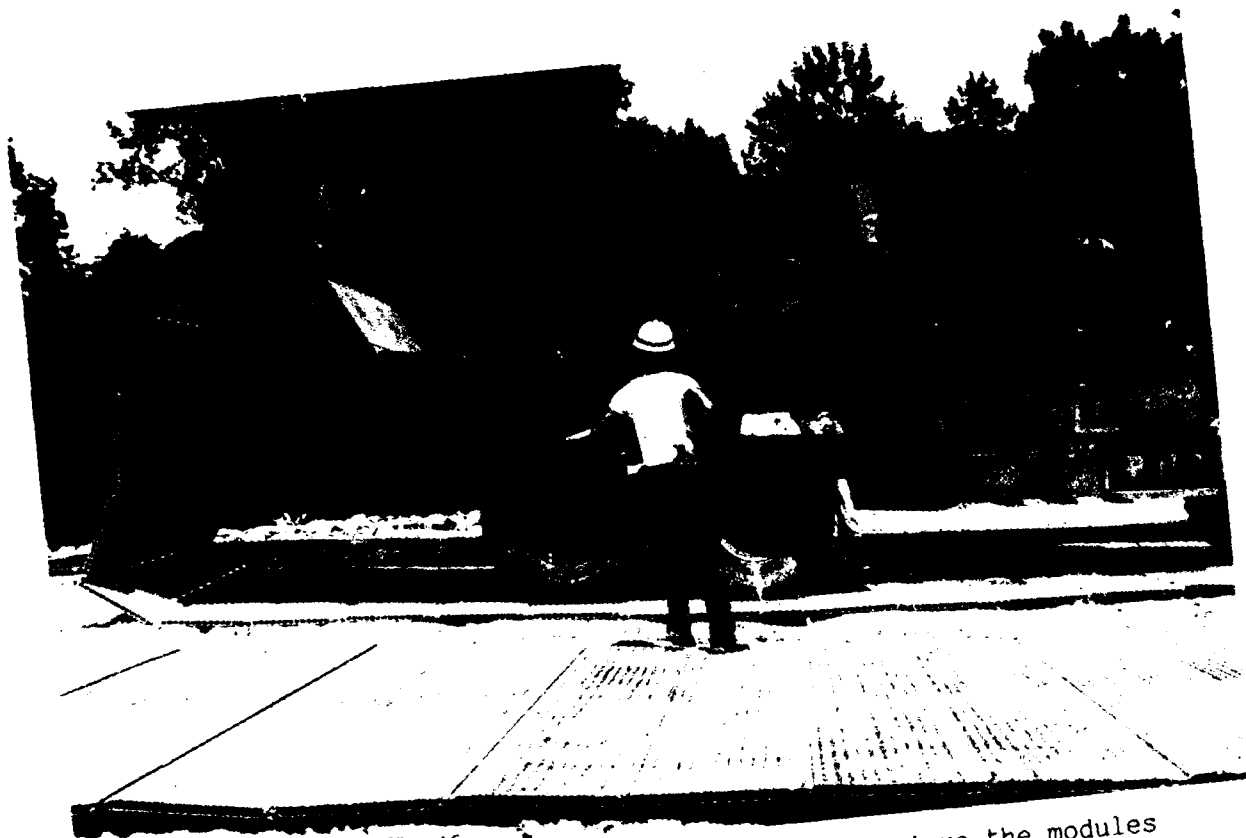
Photo 27. Using the rotation fixtures to retrieve the modules
